## Enclosure 5. Photograph index

49 photographs of the floor at the property, taken by the family.

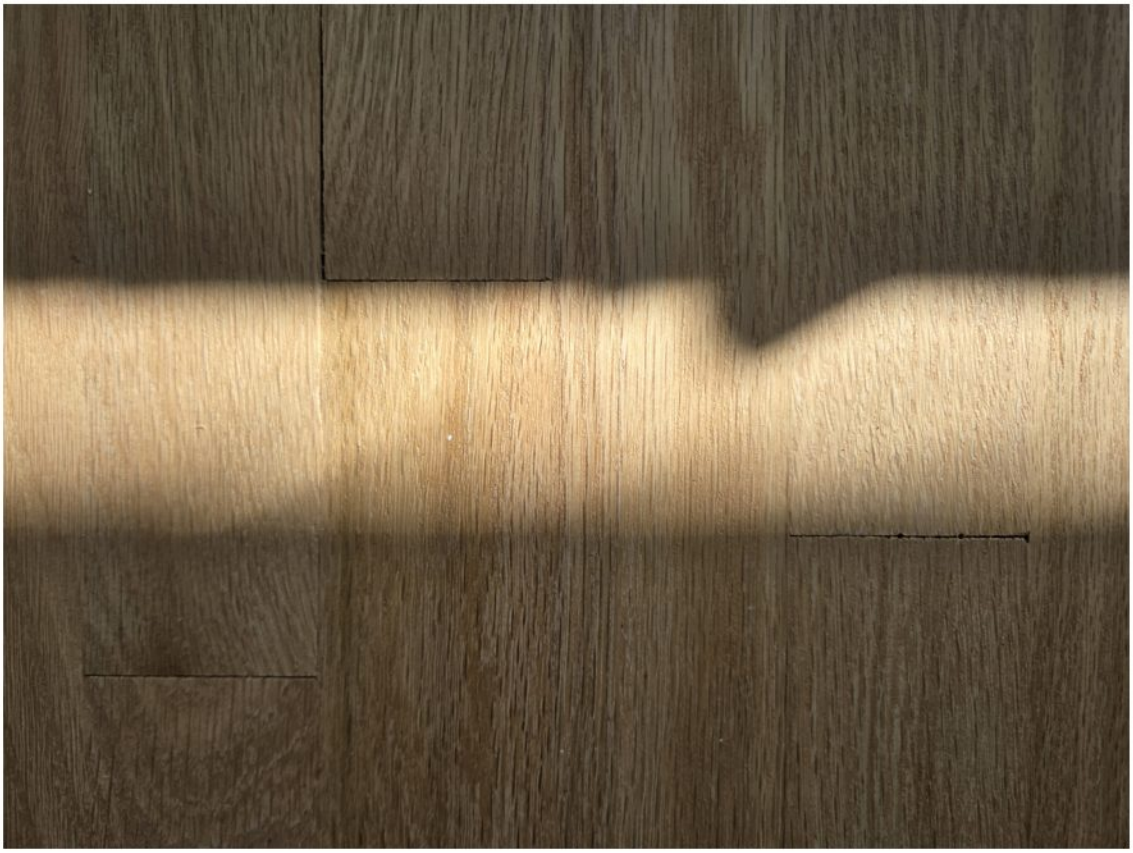
**2026-09-22 photo 35**

OVERALL, living room, wide
